Technical Note N-921

CORROSION OF MATERIALS IN HYDROSPACE

PART III - TITANIUM AND TITANIUM ALLOYS

NAVAL CIVIL ENGINEERING LABORATORY
Port Hueneme, California

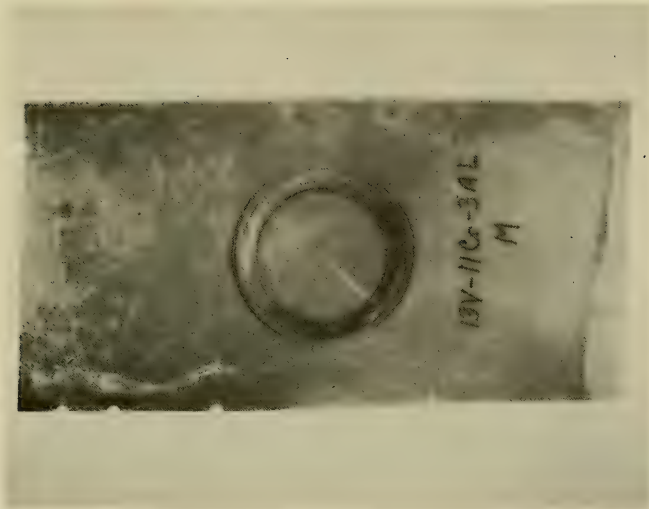
Figure 3. Circular weld (3" diameter) in 6" x 12" specimen, unrelieved.

Alloys 75A, Ti-0.15Pd, 5Al-2.5Sn, 7Al-2Cb-1Ta, 6Al-4V and 13V-11Cr-3Al were exposed with an unrelieved 3-inch diameter circular weld bead in the center of 6" x 12" specimens as shown in Figure 3. Only the 13V-11Cr-3Al alloy failed by stress corrosion cracking because of the residual welding stresses. Cracking occurred during surface exposure of 181 days, during 403 days of exposure at a depth of 6,780 feet, during 751 days of exposure at a depth of 5,640 feet, and during 402 days of exposure at a depth of 2,370 feet. The cracks in all cases were radial across the weld beads, a typical crack is shown in Figure 7. The crack in this case changed direction by 90 degrees (left side of Figure) just outside the weld bead because of the redistribution of the residual stresses.

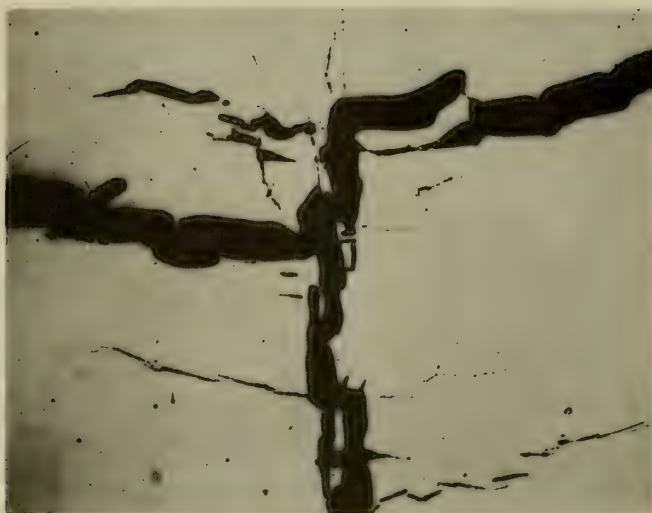
Figure 8. Irregular, branching stress corrosion crack in 13V-11Cr-3Al. Unetched. X100.

Metallographic examination of a polished section of the crack taken in the plane of the sheet where it changed direction showed that the path of the crack was irregular and branching in nature as shown in Figure 8. After etching and reexamination it was found that the crack was predominantly transgranular as shown in Figure 9.
